SENIOR CENTER

Lake Elsinore, CA

Roof Condition Report

Inspection Date: 03/22/2022

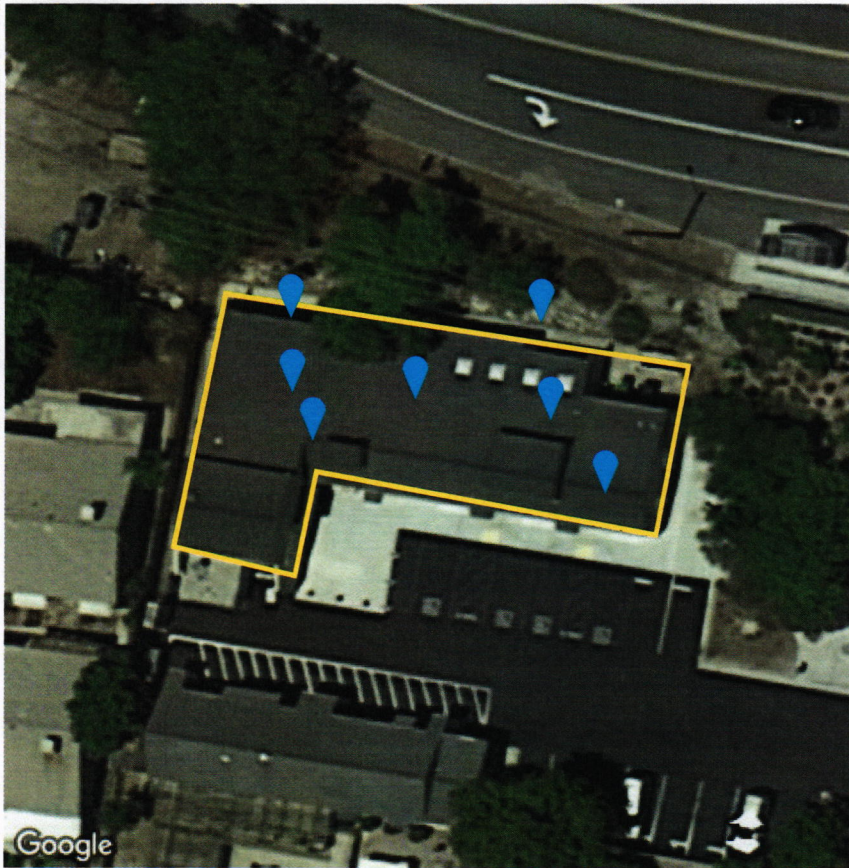
Section A Overview: Building

Replace

Major

Replace this section.

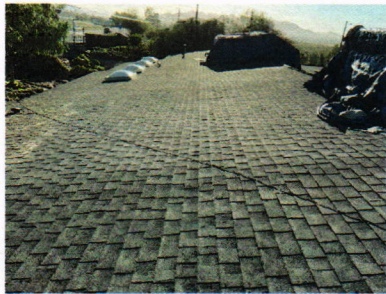
Figure 1

Detail AD-1: Shingle Roof

Shingle Roof

Shingles have met their lifespan, fiberglass exposed, bridging and frailty.

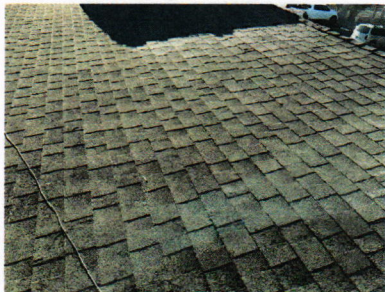
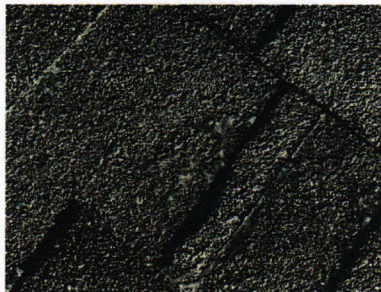
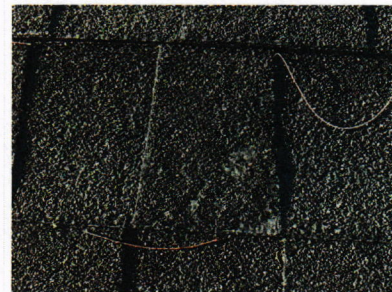
Issue AI-1: Membrane deterioration

Membrane surface deterioration include erosion, wearing away of the membrane surface and crazing or hairline cracking.

Membrane deterioration affects the strength and watertight integrity of the roofing system.

Major

Requires Repair

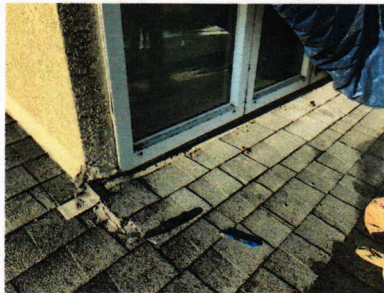
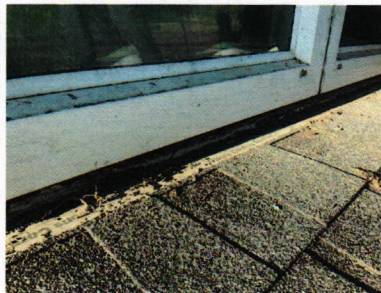
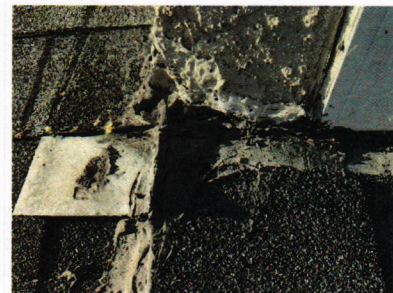
Issue AI-2: Caulking/sealants deterioration

Caulking/sealants are used to fill small areas against water.

Caulk/sealant is considered a maintenance item. When sealant deteriorates, it will allow water to enter the building or other structural components.

Major

Requires Repair

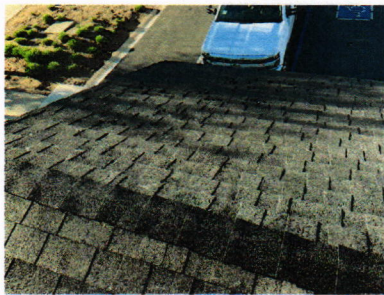
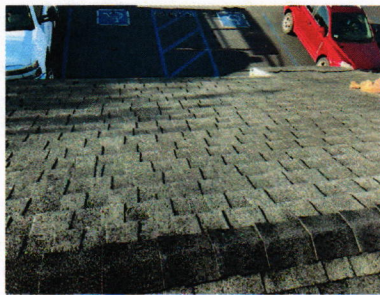
Issue AI-3: Membrane deterioration

Membrane surface deterioration include erosion, wearing away of the membrane surface and crazing or hairline cracking.

Membrane deterioration affects the strength and watertight integrity of the roofing system.

Major

Requires Repair

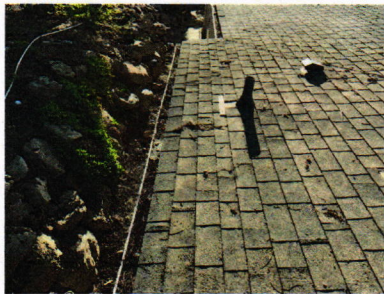
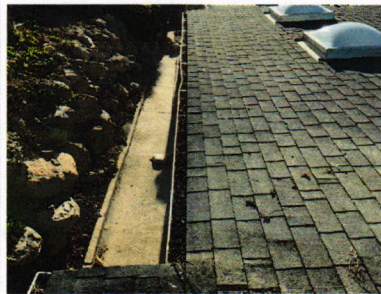
Issue AI-4: Gutter

A channel (usually sheet metal) installed along the downslope perimeter of a roof to convey runoff water from the roof to the drain leaders or downspouts.

Improperly installed or maintained or defective gutters can let water infiltrate the roof system and cause damage to the exterior of the building.

Major

Requires Repair

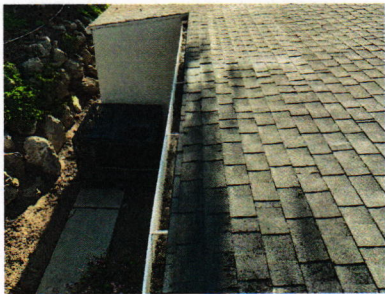
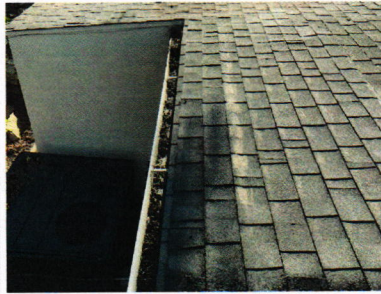
Issue AI-5: Gutter

A channel (usually sheet metal) installed along the downslope perimeter of a roof to convey runoff water from the roof to the drain leaders or downspouts.

Improperly installed or maintained or defective gutters can let water infiltrate the roof system and cause damage to the exterior of the building.

Major

Requires Repair

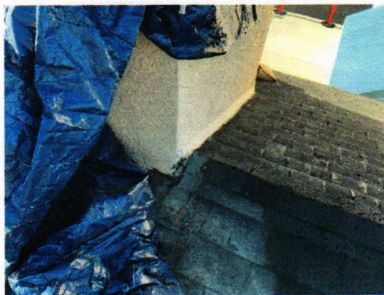
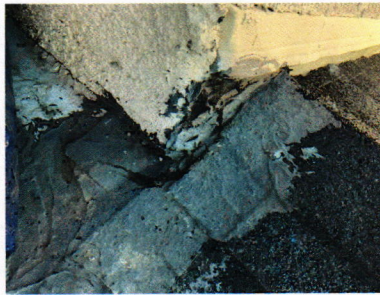
Issue AI-6: Caulking/sealants deterioration

Caulking/sealants are used to fill small areas against water.

Caulk/sealant is considered a maintenance item. When sealant deteriorates, it will allow water to enter the building or other structural components.

Major

Requires Repair
